# THE REMR

## BULLETIN

May 1996

# Seismic Strengthening of Hotel Oakland Revisited: A Case Study

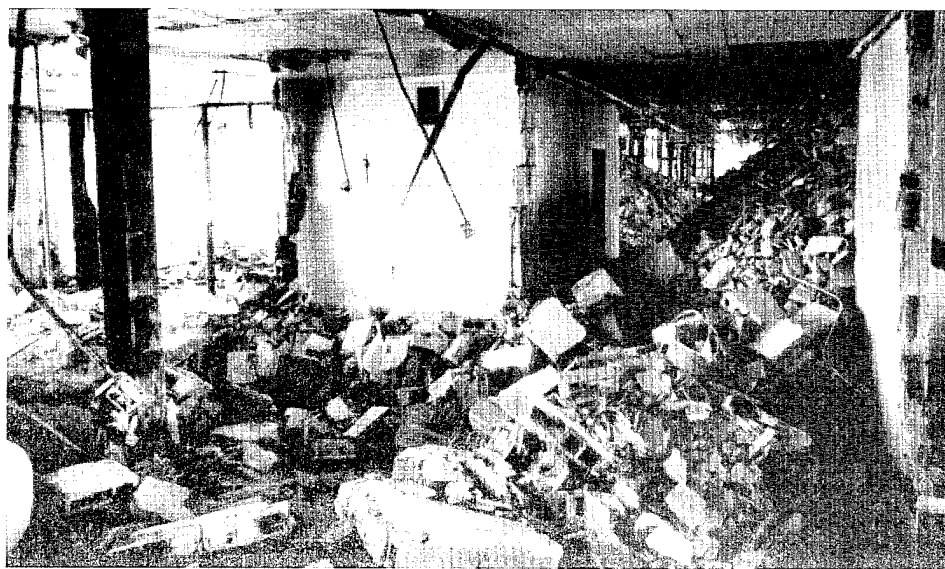
Figure 2. Clay tile partition rubble from 1979 renovations

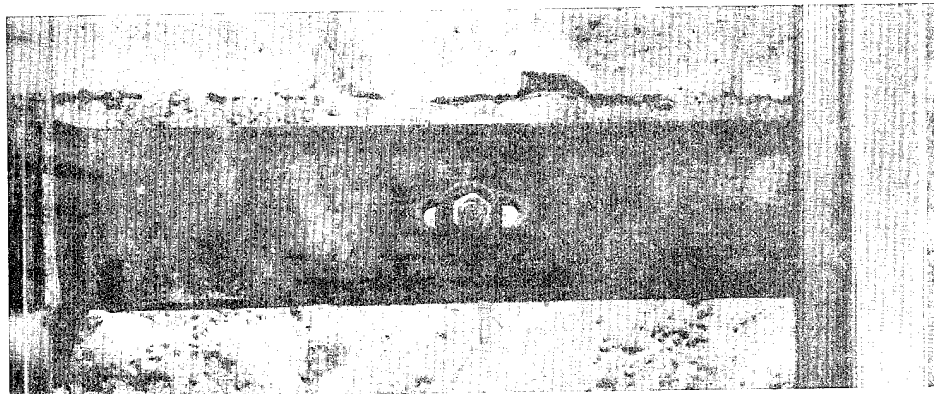
Figure 4. Detail of basketing anchor

The system devised was incorporated into the new wall furring that was applied within the steel frames of the exterior walls (Figures 3 and 4). Heavier structural studs were mixed in with the basic stud-furring system and were spaced so that wall anchors could be secured on approximately 3-ft centers in both vertical and horizontal directions. The wall anchors were 1/2-in.-diam bolts that were long enough to extend from the structural studs through the two interior wythes of the exterior wall and into the face brick. The bolts were inserted into the wall through holes drilled into the brick to a depth including partial penetration in the face brick. They were then anchored to the brick with polyester-resin epoxy cartridges.

To complete the wall anchorage, the bolts were attached to plates that spanned adjacent structural studs. The stud system then provided a positive anchorage detail to the floor framing above and below. Thus, the exterior wall system was reinforced with steel studs having the capacity to brace the walls against out-of-plane forces after failure of the brick. The system was intended to hold the brick in place, reduce potential falling hazard, and use the crushing of the brick during an earthquake for its energy-absorbing value.

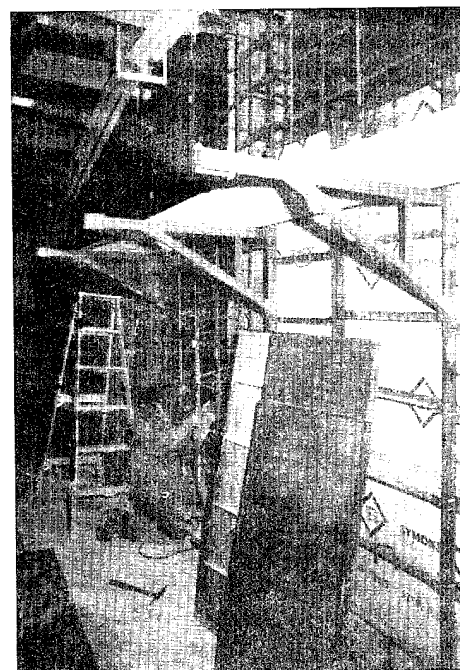
Figure 5. Forming for interior shear walls

Reinforcement of the exterior brick walls was important to the performance of the building in an earthquake, but it was only part of the story. To provide additional strength and ductility to resist major earthquakes, a new system of reinforced-concrete shear walls was designed to be added around the stair and elevator shafts (Figure 5). This system was well distributed around the building in the upper stories and was supplemented by additional shear walls from the second floor down to the foundations.

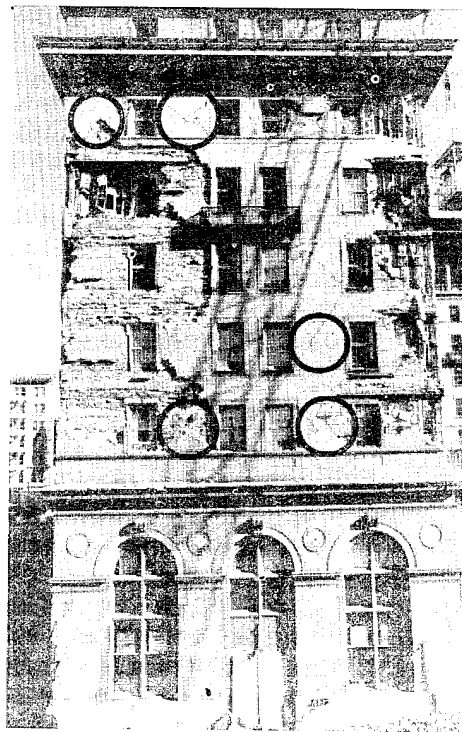
The most significant damage sustained by the hotel was cracking of some of the exterior brick walls. Although not load-bearing, these brick walls were the stiffest elements in the building, and they resisted the main thrust of the earthquake force. The damage was manifested as diagonal (X) cracks in the wall piers with virtually no cracking in the horizontal spandrels (Figure 6).

In the most severely damaged wing, the cracks were over 1/2 in. wide, with complex fracturing through the entire thickness of this wall. There were also areas where the face brick had fallen and other areas where it was loose. The damage in this area was enough to create a potential life-safety hazard that could not be ignored. An aftershock could dislodge portions of the wall that could fall on people below. It appeared that the brick in this area would have to be removed and replaced.

Figure 6. Damage to southwest facade after removal of loose brick

The exterior brick walls required significant work to repair the cracks caused by the earthquake. The cracks were injected with epoxy to restore original strength, and the finish was then patched to match the adjacent surfaces as closely as possible. The restoration process was complicated by the effects of cleaning on the existing material and on the new face brick and mortar.

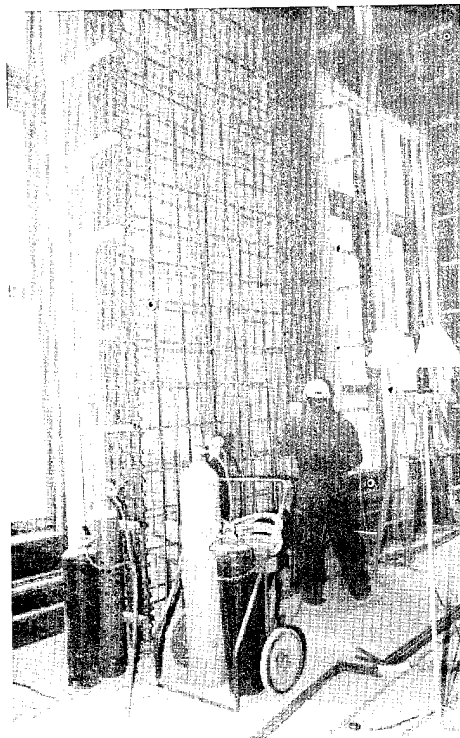
**Figure 7. Strengthening of walls behind historical facades**

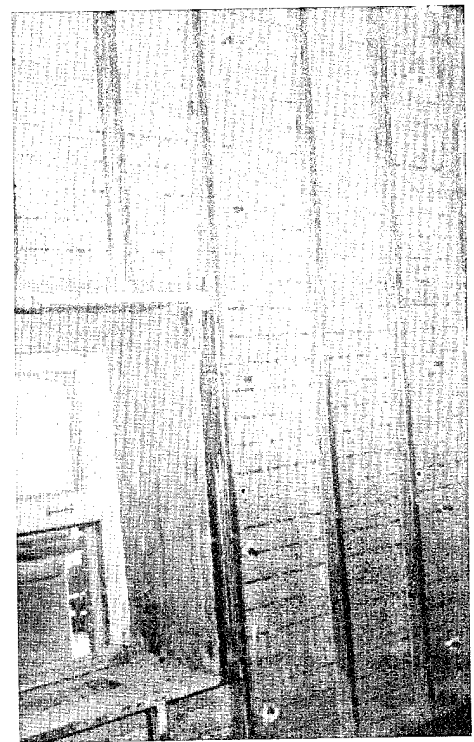
**Figure 8. Strengthening of typical upper floor walls**
